ControlLogix Enhanced Redundancy System, Revision 20.058_kit2

1756-RM, 1756-RMXT, 1756-RM2, 1756-RM2XT

These release notes describe enhancements, corrected anomalies, known anomalies, restrictions, and application notes for the enhanced redundancy system revision 20.058_kit2 or earlier.

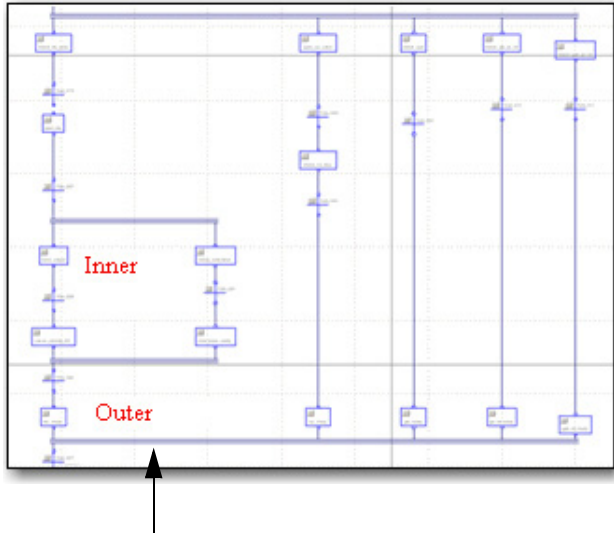
| Cat. No./System Component | Enhanced Redundancy System Revision | Description |
|--|---|--|
| 1756-L61 1756-L62 1756-L63 1756-L63XT 1756-L64 1756-L65 1756-L71 1756-L72 1756-L73 1756-L73XT 1756-L74 1756-L75 | 20.054 | <p>CORRECTED: An anomaly can occur when you nest simultaneous branches in a sequential function chart (SFC) routine as shown in this graphic.</p> <p style="text-align: center;">Bottom-most Steps</p> <p>During normal operations, the logic does not step out of a simultaneous branch until all incoming legs have reached their bottom-most step. In the example that is shown, the logic does not step out of the Outer simultaneous branch until the left-most leg has stepped out of the Inner simultaneous branch.</p> <p>The first time through the SFC routine, the application works as expected. On subsequent scans, however, the chart steps out of the Outer simultaneous branch even though the left leg has not reached the Inner simultaneous branch yet.</p> <p>This behavior occurs because the information in the bottom step, that is, the step next to the word Outer, remains from the previous scan. This stale information incorrectly causes the transition to move on as if the left leg is at the bottom step when it actually is not.</p> <p>To work around this anomaly, confirm that all incoming legs have reached their bottom steps in the transition. You can check the .x bits to make sure that the bottom-most step of each converging leg is active before allowing the chart to advance. This check can be added to the transition logic already present.</p> <p>For example, the steps in the following expression are the bottom steps (see the previous graphic) of the incoming legs. Each step has a timer. The transition does not move on until all step timers have reached their preset value.</p> <p>The expression can be modified to be sure that those steps are truly active. This expression is the original expression:</p> <pre>// Unit is ready to Transition Step1_ready.dn and Step2_ready.dn and Step3_ready.dn and Step4_ready.dn and Step5_ready.dn</pre> <p>This expression is the modified expression to work around this anomaly.</p> <pre>// Unit is ready to Transition Step1_ready.x and Step2_ready.x and Step3_ready.x and Step4_ready.x and Step5_ready.x and Step1_ready.dn and Step2_ready.dn and Step3_ready.dn and Step4_ready.dn and Step5_ready.dn</pre> <p>IMPORTANT: The x bit is cleared when the chart transitions out of a step.</p> <p>If you add this check to the condition, it forces the engine to wait until all of those steps are genuinely active before advancing out of the simultaneous branch.</p> |

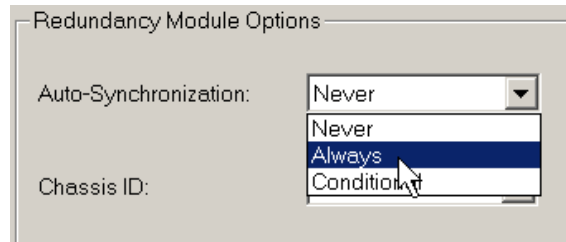
23. In the RMCT, from the Auto-Synchronization pull-down menu, choose your preferred method.

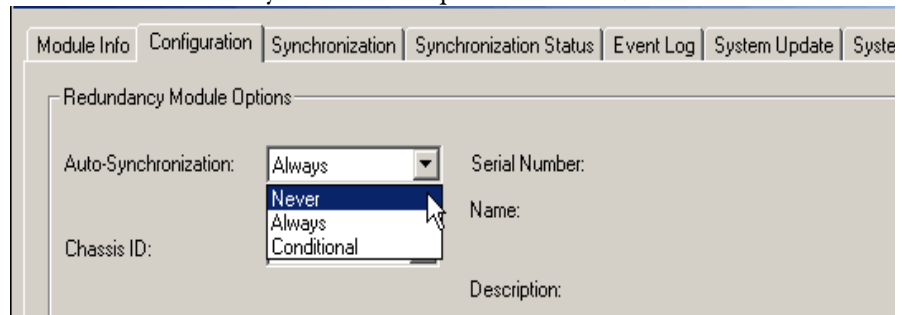
- Click the Configuration tab in the RMCT.
- From the Auto-Synchronization pull-down menu, choose Never.

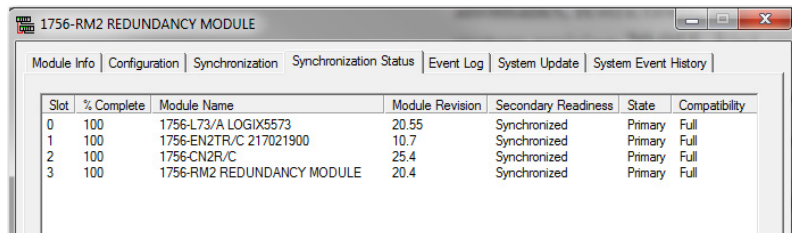
20. After the update completes, connect the Ethernet cable to the secondary Ethernet module, and wait for communication to resume on the network.
21. To verify that compatibility is Full for all communication modules in the chassis, check the Synchronization tab in the RMCT.

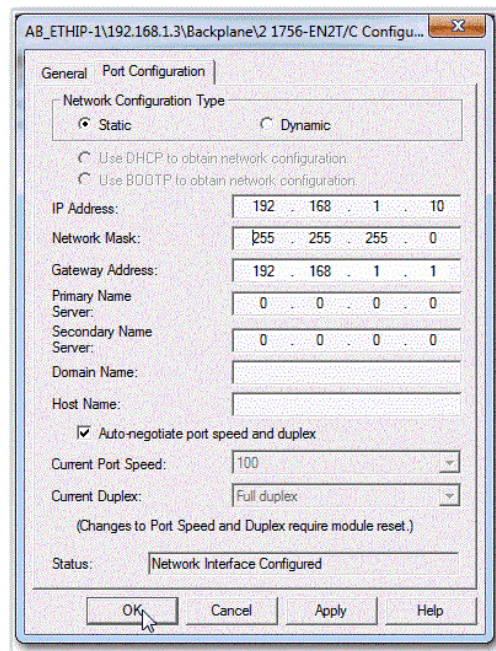
- b. On the Port Configuration tab, enter the desired IP address, Network Mask (if not entered automatically), and click OK.

This example uses the values in the following screen capture.
